A Review on Seismic Retrofit of Beam-Column Joints

Sreadha A R, Dr.C.Pany and M V Varkey, "A Review on Seismic Retrofit of Beam-Column Joints", *International Journal for Modern Trends in Science and Technology*, 6(9): 80-93, 2020.

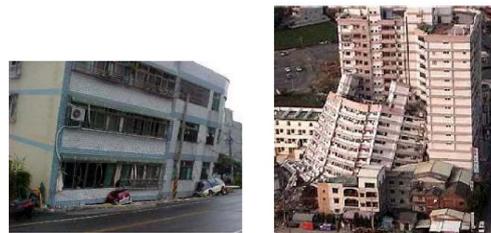
Fig 1: Local failure mechanism [1]

Fig 2: Global failure mechanism [1]

For building structures, the seismic failure mechanisms have two types, the local and the global failure mechanism, as shown in Fig.1 and Fig 2. Frame-supported structure or soft storey structure, block structure, are the structural forms that are vulnerable to local failure. Ductile frame, shear wall structure, tube structure, cluster tube structure, and mega frame structures are the types of structure to form global failure.

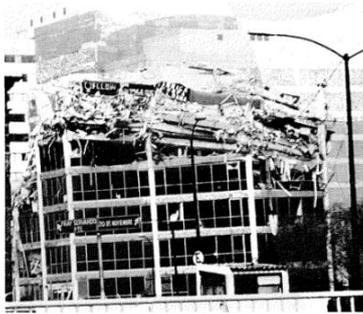
Fig 3: Collapse of upper storeys [2]

On September 19, 1985, an 8.1 magnitude earthquake took place off the Mexican Pacific coast between Jalisco and Oaxaca (Fig 3). A structure on soft soil subjected to severe ground motion will have its fundamental period lengthened as a result of both foundation rocking rotations and structural

damage. Foundation rocking increases the duration of vibration of the structure, increases the contribution from higher modes of vibration, and results in greater forces in the upper floors. These effects have resulted in damage to the middle and upper floors of several buildings. The characteristics of the motion of the ground, the torsional eccentricities, the contribution of the base rocking on the soft soil, and possibly the friction between the wings, probably all contributed to the failure.

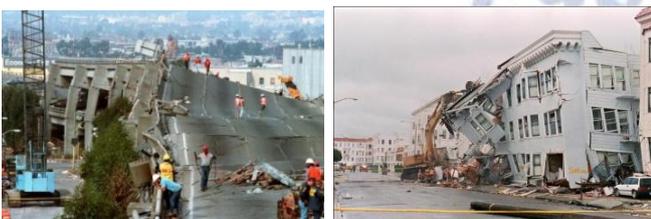
Fig 4: Collapse of bridge and building [Los Angeles Times]

An earthquake of magnitude 7.1 occurred on 17 October 1989 at Pacific daylight time in northeast Santa Cruz, California (Fig 4). This earthquake has caused significant extensive damage to buildings and bridges in the Greater San Francisco Bay area. In addition to the low seismic force levels of construction, the major contributing factors resulting in significant damage or failure were: 1) loss of support for the superstructure due to large longitudinal movements or lack of control over supports. 2) Extreme settlement of support and approach slabs due to the presence of soft soil or filling. 3) Poor detailing of column tie reinforcement in bridge piers, including excessive tie spacing's and inadequate anchorage of the free ends of the ties. 4) Inadequate anchorage of longitudinal column reinforcement into foundations as well as into the superstructure, resulting in pull-out reinforcement failures at those sites.

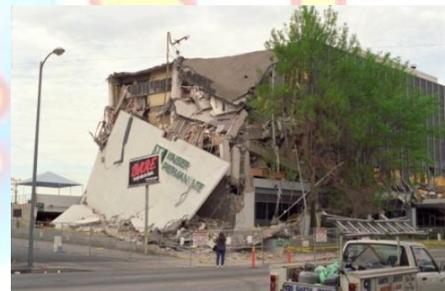
Fig 5: Partial collapse of the building [magazine.ucla.edu]

An earthquake of magnitude 6.8 damaged a variety of structures on January 17, 1994, in Northridge (Fig 5). It should be noted that many of the structures damaged during the 1994 Northridge earthquake were older structures that were designed using earlier codes. While the damage from this earthquake illustrated the importance of proper design and detailing to achieve ductile responses of concrete structures. These include the following: (1) Most of the reinforced concrete structures that were damaged were older, non-ductile structures. (2) Precast concrete structures must have adequate connections between beams and columns and adequate load paths must be provided for lateral forces through floor and roof diaphragms. (3) The 1994 Northridge earthquake provided evidence that the ductile frame members were appropriate. (4) The earthquake damage clearly demonstrated the known deficiencies in older tilt-up structures due to inadequate connections between the floor and roof diaphragms and the tilt-up wall panels.

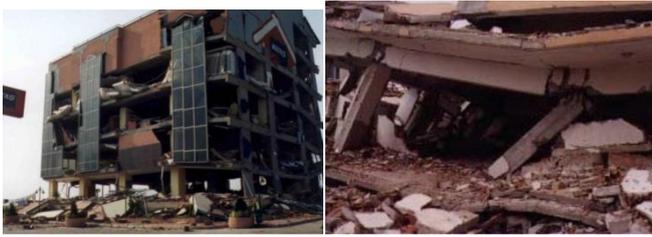
Fig 6: Collapse of building [5]

On August 17, 1999, an earthquake of magnitude 7.4 occurred along the North Anatolian Fault (Fig 6). The main reasons for the collapse are the following: (i) The presence of partial height masonry infills led to failure in some columns at the level of the top of the damaged infills where the columns contained splices of the vertical bars. (ii) Connection failures like cantilever – column, cantilever – beam, and beam–stringers connection. (iii) Site visiting teams from many countries, including experts in Turkey, generally recognise that the primary factor leading to poor structural performance was the inadequate and sometimes non-existent regulatory enforcement of both design and construction.

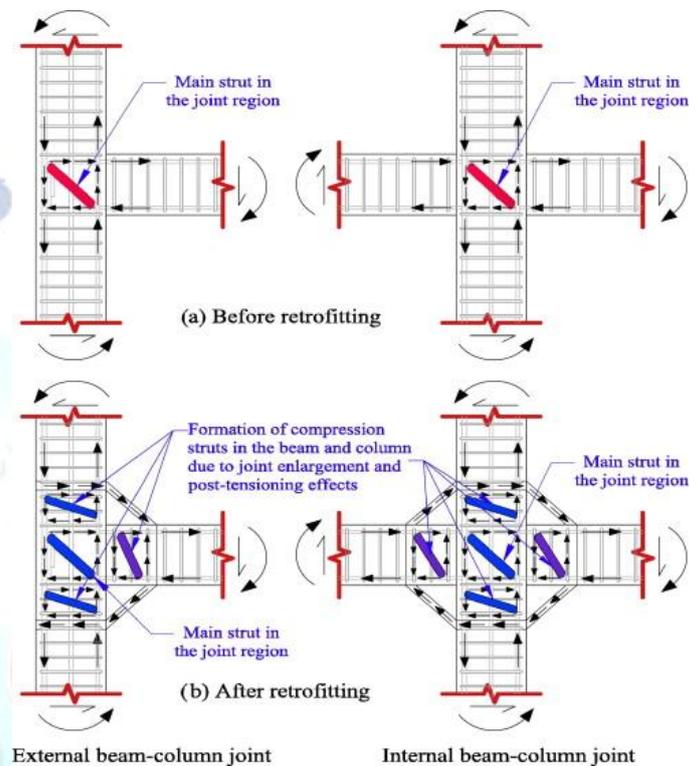
Fig 7: Beam-column joint before and after retrofitting [8]

The decision to strengthen the structure before the occurrence of an earthquake depends on the seismic resistance of the building. The structural system of the deficient building should be sufficiently reinforced to obtain the required degree of seismic resistance. The term reinforcement includes technical interventions in a building's structural system which improve its seismic resistance by increasing strength, rigidity, and/or ductility. A reinforcement scheme consists of one / many reinforcing techniques to remedy the structural defect. Such schemes are specific to the structural system and material type. Minakshi V. Vaghani et al. [6] and Komal Bedi [7] gives a description of major techniques that are used for reinforced concrete buildings. An example fig

showing before and after retrofitting technique is shown in Fig 7. Depending on the various forms and structural conditions various seismic retrofit techniques are available.

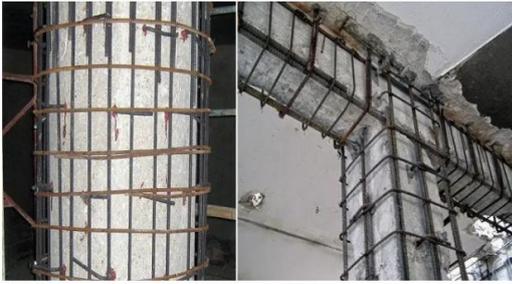
Fig 8: Concrete column beams strengthening [theconstructor.org]

For the column, jacketing is excellent but may not be too effective for beam or slab. It is possible to jacket existing beams, columns, or joints with new overlays in reinforced concrete, steel, or fibre wrap. The new materials are to be designed and constructed for composite action with the existing concrete. Where reinforced concrete jackets are used, details to improve ductility shall be provided in the design. Retrofitting of the columns is often critical to a structure's seismic performance. During earthquakes, columns can never be the weakest elements of the building structure to prevent the mechanism of the storey. In a building structure a column's response is influenced by its axial load, flexure, and shear combined. Column jacketing can therefore be used to increase column shear and flexural strength so that the columns do not get damaged. For jacketing, fibre-reinforced composite (FRC) material is used during retrofitting of columns.

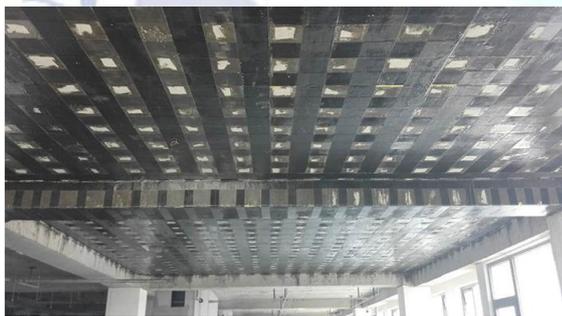
Fig 9: Strengthening by fibre reinforced polymer (FRP) wrap [www.horseen.com]

A fibre-reinforced polymer (FRP) is usually made up of high tensile continuous fibres directed in the desired direction in a specialised resin matrix. These continuous fibres are bonded to the member's outer surface to be reinforced in the direction of the tensile force or as a normal confining reinforcement to its axis. FRP may improve the deficient member's shear, flexural, compressive capacity, and ductility. The most common types of fibres used in most commercially available FRPs are glass fibres. In structural applications FRP systems are typically used. FRP reinforcement is a fast, smooth, effective and aesthetically pleasing technique for rehabilitating reinforced concrete structures with pre-stressed concrete. FRP systems have high physical and chemical deterioration or mechanical actions as opposed to steel plates.

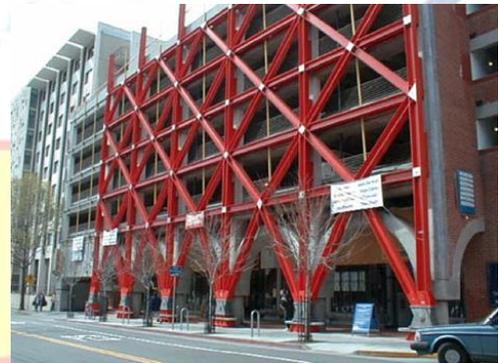
Fig 10: Installation of Friction Damper [www.sensequake.com]

Usually, friction damper is part of a steel brace structure placed within a column-beam frame, composed of specially coated steel sheets which are attached together. The commonly used friction damper systems are created by the X (friction damper in the centre of the X) within the rectangular column-beam structure. or a diagonal (friction damper is around the diagonal). At the

column-beam joints such a friction damper mechanism is connected to the structural frame by means of connectors. The role of the friction damper system is identical to that of an automotive shock absorption device. Earthquakes release energy through ground shaking movements, which cause seismic loads to a system of buildings. Friction dampers absorb the energy (or load) induced by the earthquake when the steel plates move at a fixed slip speed toward each other, i.e. dissipate the energy caused by the earthquake by friction-generated heat energy. The installation of friction dampers to an existing building increases the seismic load-bearing capacity of the building structure by reducing the building's need for seismic resistance on existing load-bearing components.

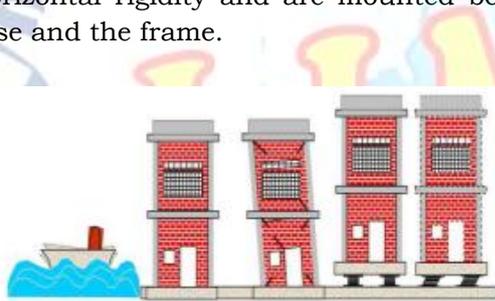
Fig 12: Principles of Base Isolation Technology [7]

Base isolation is typically ideal for low to medium-rise structures, normally up to 10-12 floors high, with their specific frequencies within the range of predicted dominant earthquake frequencies. In evaluating the applicability and effectiveness of seismic isolation, superstructure characteristics such as height, width, aspect ratio and rigidity are important. The region's seismicity and the soil conditions underlying it should also be considered in feasibility studies and design phase. The restriction in applying base isolation is the large relative displacements at the insulation level between the superstructure and the supporting field. To withstand the expected large displacements, clearance around the building must be given and preserved over the life of the construction. Through the introduction of increased stiffness and energy dissipation processes in the insulation system, such displacements may be minimised. Insulators have low horizontal rigidity and are mounted between the base and the frame.

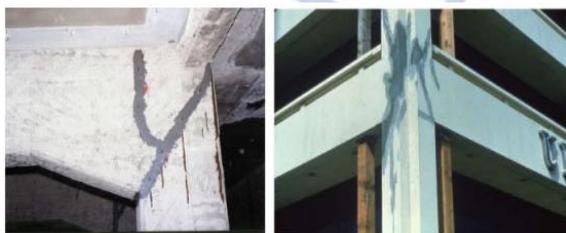
Fig 13: Application of the epoxy resin & cement grout injection in beam-column joint [9]

Grout injection is a common technique of strengthening, as it does not change the aesthetic and architectural characteristics of the existing buildings. The key aim of injections is to preserve the original integrity of the retrofitted wall and to fill the voids and cracks present in the masonry due to slab will prevent shear failures from punching.
